City of Baltimore Wet Smoke and Dyed	Page 1 of 1	
Sewershed: Gwynns Falls	Company: Savin	Date: 4/28/2009
Test to be performed: Smoke Dyed Water X	Ground Condition: Dry ✓ Damp □ Wet □	Supervisor: JAW
Manhole_ID: S03UU_013MH	Test ID: <u>D1032-022012</u>	Notification Made: NA (Residents, Fire, 311)

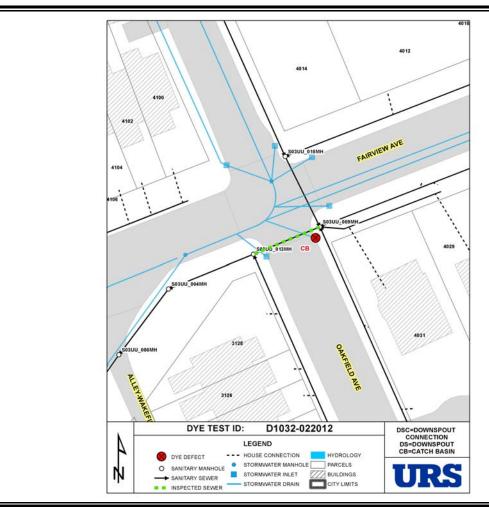
Field Sketch: Show all manholes with Numbers, Blower Placement Locations, Sandbag or Isolation Locations, Street Names, Building Addresses and Locations, Defect Locations and Photo Numbers.

Defect Loc	Obs_ClockFrom	Obs_ClockTo	Observation	Obs_Remarks
0			Start of Survey	
0			Manhole	S03UU_009MH
0			Water Level	
2			Dye Test Visible	MH WALLS
4			Joint Offset Large	IN OAKFIELD LINE
4			Dye Test Visible	AT JOL
4	12	04	Hole Void Visible	AT DROP IN OAKFIELD LINE
5.099999905	12	12	Broken Void Visible	IN OAKFIELD LINE
5.099999905			Dye Test Visible	FROM BROKEN PIPE ON OAKFIELD LIN
10			Abandoned Survey	LINED PIPE, NO MORE LEAKS SEEN
